Kotzebue Electric Association, Inc

Wales Diesel-Off High Penetration Wind System

9/25/2011

Quarterly Project Report

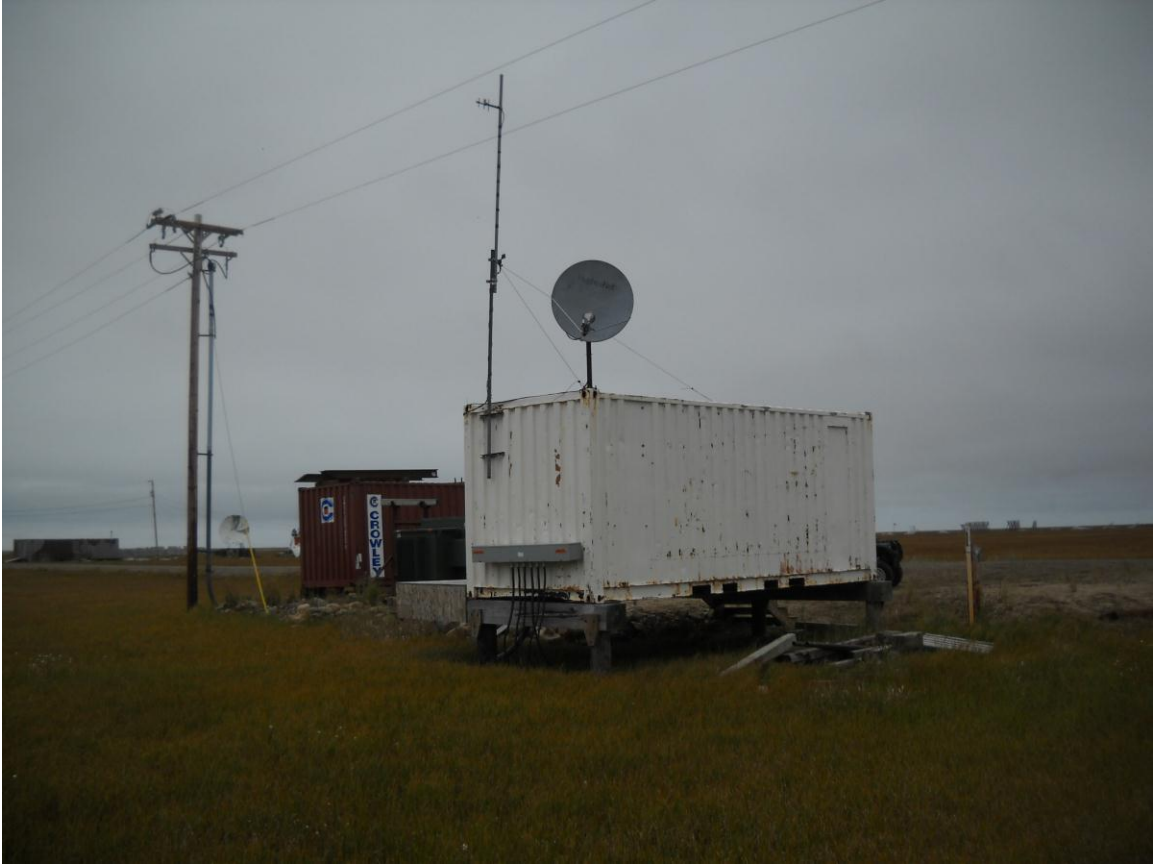
Picture 2: Control connex with newly mounted HughesNet satellite internet dish.
