Kotzebue Electric Association, Inc
1/3/2011
Quarterly Project Report

Wales Diesel-Off High Penetration Wind System

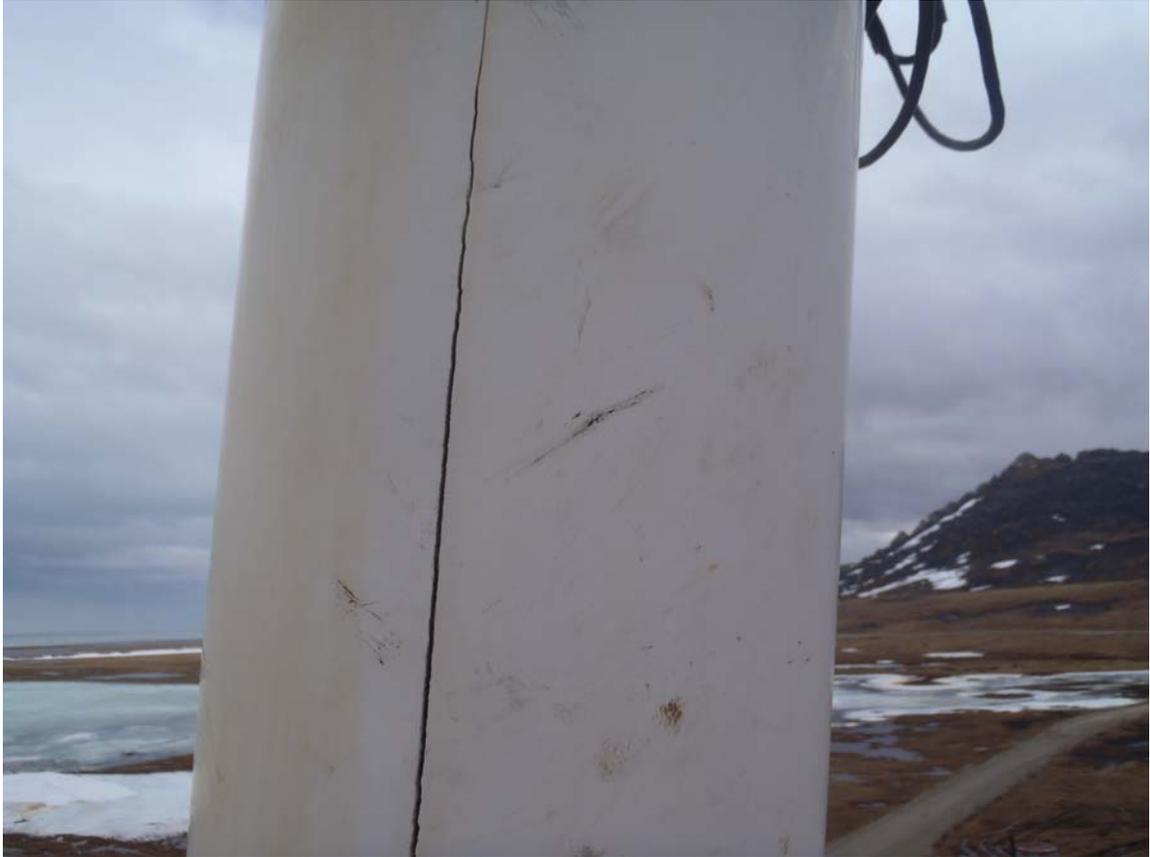
8. Blades structurally seem to be fine: bending without cracking noise, no rattling inside the cavity, however, there are surface cracks of concern.
 - a. Surface cracks were observed on all leading edges of the blades on Turbines 1 and 2.
 - b. It seems the crack is indeed within the surface structure of the blade and could be repaired with epoxy on the next site visit.
 - c. Cracks were between 1 and 4.5 feet in length, and 1/16 of an inch at the widest point.
 - d. Minor swelling was present in the end of the blade due to water buildup, which made the tip brakes fit very tight.
9. Generator was working correctly in both motor jog and connection states on both machines.
 - a. Phase rotation was verified
 - b. Correct Amperage in motor jog and connection modes
 - c. Voltage was correct line-line and line-ground.

Picture 1: Blade Crack

As mentioned in KEA's September Quarterly Report to the Commission, further operating tests need to take place on the Wales system; however, cracks in the turbine blades currently prevent operation of the system (See Appendix 1 for photos). The blade crack repair is fairly simple and can be done with epoxy. The epoxy was shipped to Western Community Energy in September, but they did not travel to Wales prior to the onset of winter weather conditions. Severe weather and cold temperatures will prevent the repair of the turbines until sometime in the spring of 2011 (this is due to the epoxy's reluctance to bond in cold temperatures).

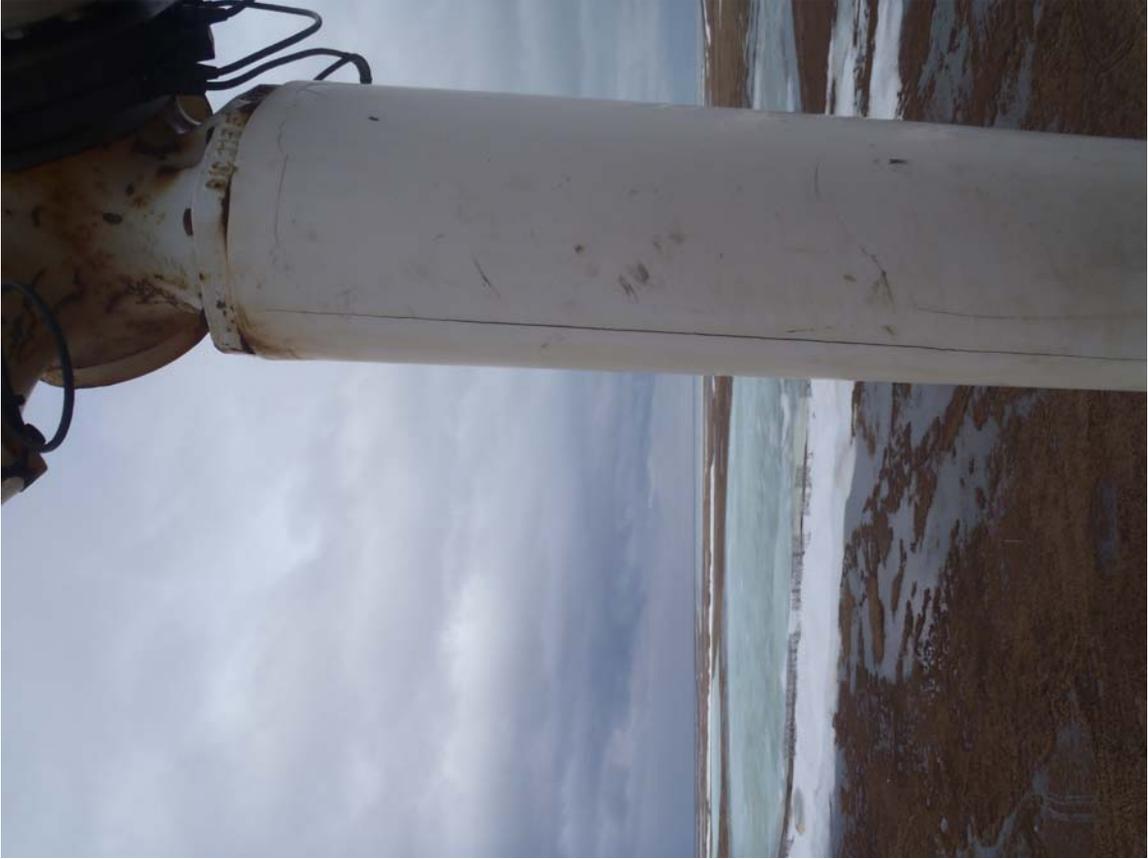
Pictures 1 and 2 show cracks in the blades and general corrosion.

Picture 2: Blade Crack and Corrosion
