Kotzebue Electric Association, Inc  
 09/15/2010  
 Quarterly Project Report

Wales Diesel-Off High Penetration Wind System

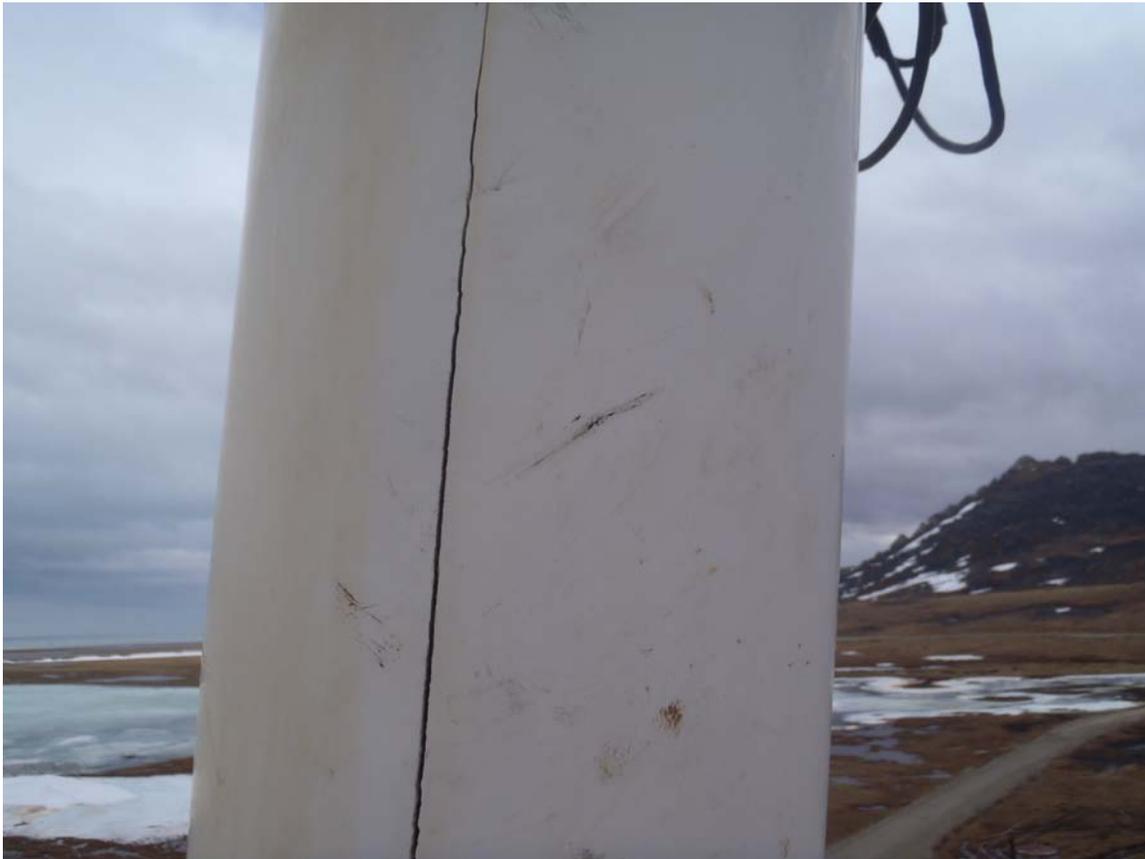
8. Blades structurally seem to be fine: bending without cracking noise, no rattling inside the cavity, however, there are surface cracks of concern.
  - a. Surface cracks were observed on all leading edges of the blades on Turbines 1 and 2.

- b. It seems the crack is indeed within the surface structure of the blade and could be repaired with epoxy on the next site visit.
  - c. Cracks were between 1 and 4.5 feet in length, and 1/16 of an inch at the widest point.

**Picture 1: Blade Crack**

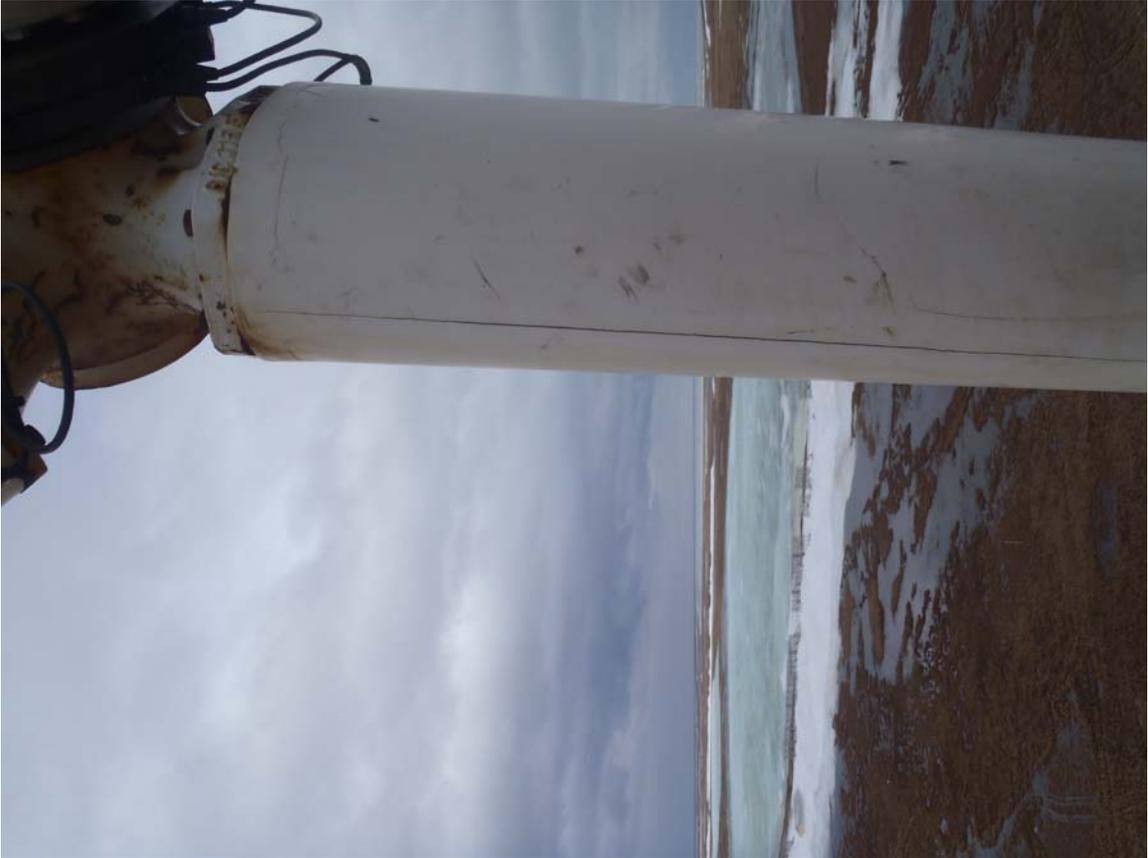
Further operating tests need to take place, but the blade cracks currently prevent this. The epoxy is on order and should arrive in the region shortly. Sever weather in the Wales area often prevents travel, so the scheduling of site visits remains fluid. Pictures 1 and 2 show cracks in the blades and general corrosion.

**Picture 2: Blade Crack and Corrosion**
