Tanana River Hydrokinetic Energy Test Site Debris and Foundation Study

SUMMARY REPORT

PROJECT TITLE: Tanana River Hydrokinetic Energy Test Site Debris and Foundation Study

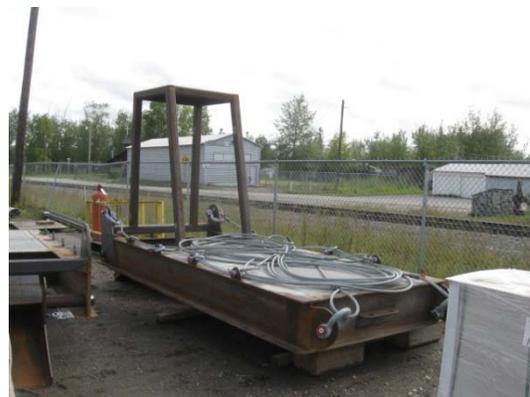
Figure 1 Anchor with MDDD mount prior to mounting spines

Preliminary and finalized designs were socialized with ORPC personnel for feedback. The final plan was to construct a pair of devices to be mounted on ORPC's anchoring system designed to secure the ORPC RivGen bottom support frame. This anchor was modified to accommodate the pair of debris detection assemblies (figures 1 and 2)

base to allow the spine to hinge down if the force applied to it exceeded a given amount (Figure 3). The spine and release devices were mounted on a steel platform affixed to an anchor base resulting in the spine bases being approximately 2 meters above the river bottom when the assembly was placed in the river channel (Figures 1 and 2).

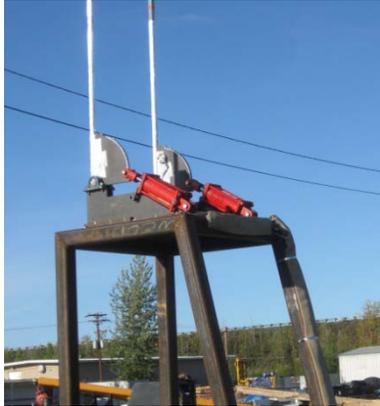
Figure 2 MDDD spines on anchor mounting platform

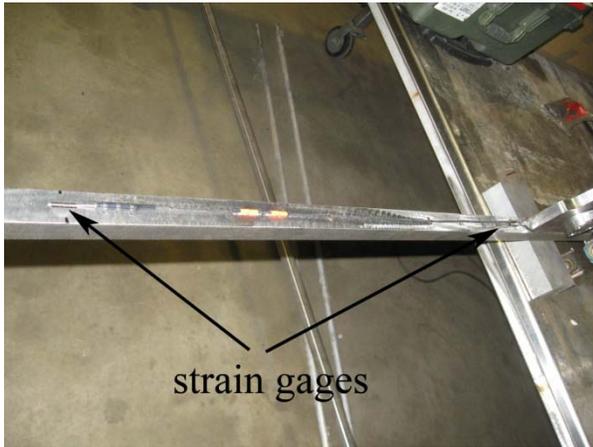
Figure 3 Strain gages mounted on steel spine

with one gage centered 10 cm above the spine support cam and the other centered 76 cm above the spine support cam. A special spot welding machine was provided on loan by Kyowa Electronic Instruments. The gage elements were encapsulated quarter bridge 3 wire systems with a bridge adapter installed in the signal cable approximately 2 meters from the gage. A 150 meter cable ran from each strain gauge to the data logger. The use of a strain gage bridge adapter was necessary because signal cable length was excessive for use with a quarter bridge gage. The adapter completed the bridge circuitry to make a 4-wire full bridge configuration. The gage, bridge and cable assembly were fabricated by Kyowa for use in an underwater application. Strain gage bridge 5 VDC excitation was provided by the Campbell CR3000 micrologger. The strain gage output was an analog voltage read by the CR3000.

Strain gages were supplied by Kyowa Electronic Instruments. Kyowa was the only vendor found that could commit to supplying weldable strain gages and cable assemblies for long term underwater use. Unfortunately, Kyowa suppliers were affected by the March 11, 2011 Tohoku earthquake and tsunami in Japan. This resulted in an indeterminate lead time before the vendor could deliver strain gages. When the vendor indicated that they could supply their product, the order was placed in mid-June and the gages arrived in Fairbanks mid August. The strain gage installation consisted of affixing two strain gages to each spine (Figure 3). The gages were spot welded to the down current side of the spine

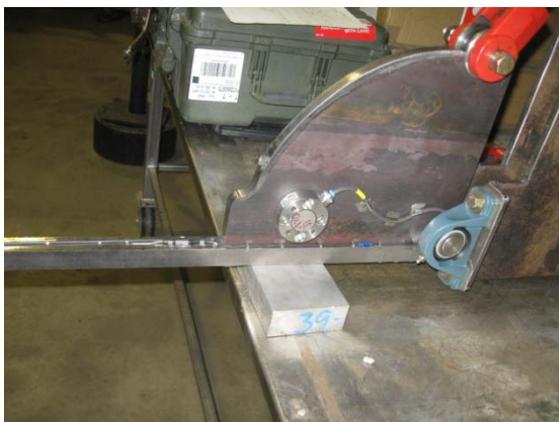
Figure 4 MDDD spine with inclinometer sensor on side of cam

The inclinometers (Figure 4) were supplied by ASM Automation. The devices and the supplied 150 meter cable were rated for underwater operation. The inclinometer output was a 4-20 ma signal and the sensor required a minimum excitation of 18 VDC. Excitation was provided by a pair of 12 V batteries in series. The purpose of the inclinometers was to indicate the attitude of a detection spine to make the strain information more meaningful. The output 4-20 ma signal was converted to a voltage signal at the CR3000 logger by means of precision 100 ohm shunt resistors supplied by Campbell Scientific. The inclinometers had a range of +/- 60 degrees on

either side of the midpoint of travel yielding a total range of 120 degrees. As deployed, the angle of a tripped spine in the horizontal position is reported as 0 degrees and the upright spine reported as 90 degrees. If the attitude of the spine tilts upstream the reported angle is greater than 90 degrees.

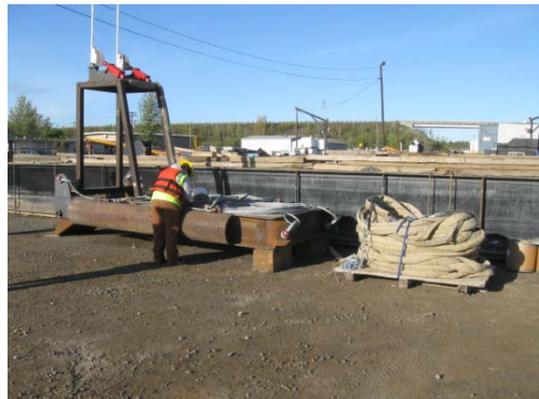
Figure 5 MDDD with signal cable shrouded in fire hose coiled on pallet

The strain gages, inclinometers and their associated 150 meter long data cables were designed for extended underwater deployment. To transition the signal cables from the deployed MDDD to an on shore signal data logger for processing, the cables were bundled and fastened to a 3/8" chain for ballast and then the cable/chain assembly was fed through multiple 50-foot lengths of fire hose that provided abrasion resistance (Figure 5). The chain provided strain relief for the signal cable bundle and kept it on the river bottom. The signal cabling terminated on the river bank in a 2'x2'x4' steel job box housing the batteries and datalogger.

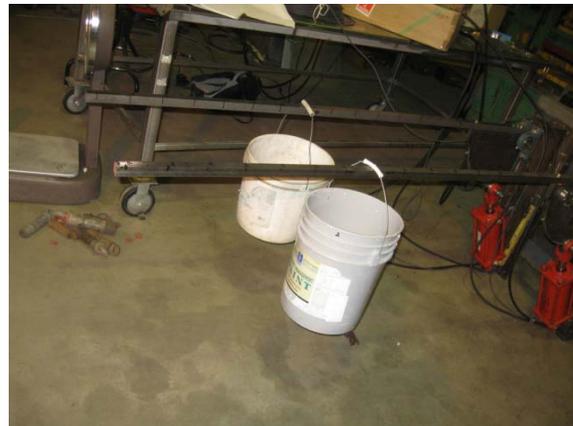
Figure 6 MDDD spines with calibration weights

In order to render the MDDD strain gage data meaningful, a calibration process was performed immediately after the spine assembly fabrication was completed on August 23, 2011 at Jon's Machine Shop. Both spine assemblies were affixed to a table with the spines in a horizontal position. The spines were marked in 10 cm increments and a known weight was suspended from each mark for approximately 60 seconds while the datalogger was recording the output of the strain gages (Figure 6). The downward force of the weight plus the force due to the weight of the steel spine was reported as a moment of force about the strain gage. A plot of the moments vs. the output of the strain gage as recorded by the datalogger was used to generate a relationship between the forces applied and the reported strain gage output.

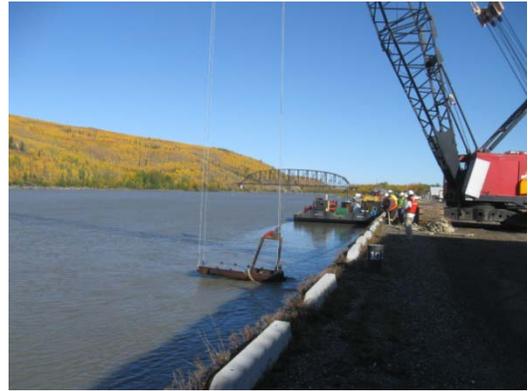
Figure 7 MDDD being lowered into water

In order to make the best use of the short time remaining in the field season, the detection spines were transported to Nenana on August 24, 2011, the day after the calibration to begin assembly of the spines to the anchor in the Crowley yard. Assembly took place on August 24, 25 and 26 in Nenana. The schedule was expedited so the MDDD would be ready whenever the deployment plan was finalized and Crowley equipment and crews would be ready to deploy the anchor and MDDD. When it became apparent that a full mid-channel deployment would not be possible it was decided to do a dockside deployment instead to test both the anchor pull resistance and MDDD performance (Figure 7).

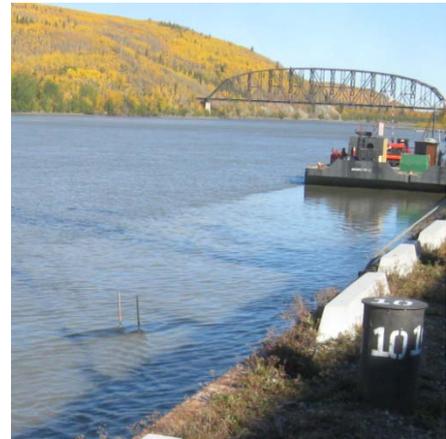
Figure 8 MDDD spines protruding above water surface after deployment

After deployment (Figure 8) the data logger system was set up on the dock. A bug was discovered in the program that caused erroneous data to be reported in a real time monitoring function of the logger. When program instructions called for monitoring the time and magnitude of maximum values within each recording period, the bug produced an unrealistic time stamp and improbable strain gage readings. Attempts were made to configure a program to resolve the erroneous data problem. As a result of spending time dockside working with the logger, it was possible to observe the slow settling of the anchor into the silt as evidenced by the reduction in the portions of the spines above the water surface. By the next morning the anchor had settled approximately 40 cm (change in river stage over night was less than 5 cm). The logger was left running through the night and a conversation about the bug was initiated with Campbell Scientific on 9/14/11.

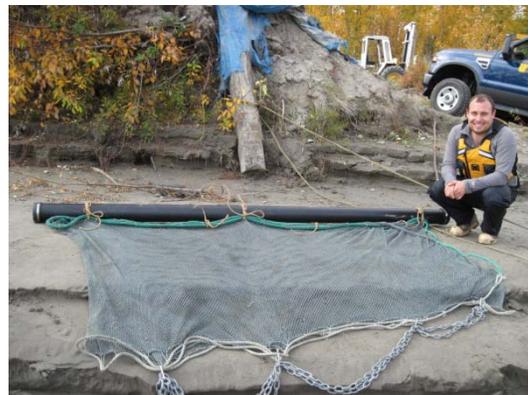
Figure 9 Surrogate debris with net float and chain

The behavior of the MDDD with objects intentionally placed in the water column, as debris surrogates, was tested on 9/16/11. Two scenarios were simulated. To simulate an accumulation of smaller debris a net was suspended from a 10' section of 4" ABS pipe acting as a float. The net used had a small mesh on the order of 1", and was approximately 4' x 24'. The net was folded over 3 times to yield a three layer net about 8' long. A 15' length of 3/8" steel chain was secured to the bottom of the net to provide weight. In essence this was a floating net curtain that hung down about 4' from the surface (Figure 9). The intention was to keep the net system above the level of the cam and follower to minimize the probability of fouling. The second type of simulated debris used two 15 gallon poly drums filled with water and a few links of steel chain making them a little less than neutral buoyancy. The poly drums were suspended from another 10' x 4" ABS pipe float.

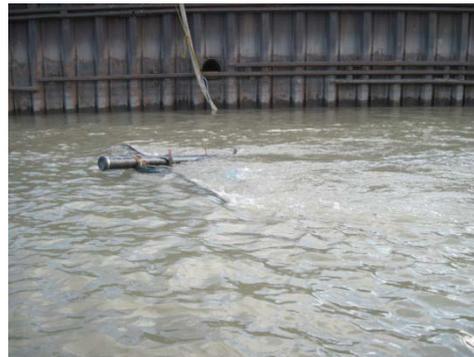
Figure 10 Surrogate debris on MDDD spines

current flow and have the float centered on the pair of spines. If the float impacted the spines and was centered, the probability was high that the float and net would remain on the spines and act like an accumulation of debris. The larger mass debris surrogate, the filled 15 gallon poly drums, was more difficult to have impact the spine. A number of attempts were required to have the poly drums impact the spines directly. When the net assembly was resting on the two spines, it was employed to catch the poly drums. A combination of the net and two poly drums was able to trip one of the spines (Figure 10). Multiple trials were performed until the net fouled on the dockside spine and could not be removed. The system was left with the net and float fouled until the removal from the water. In this configuration one spine remained vertical and the other was tripped enough so that there was no surface expression of the spine, float or net.

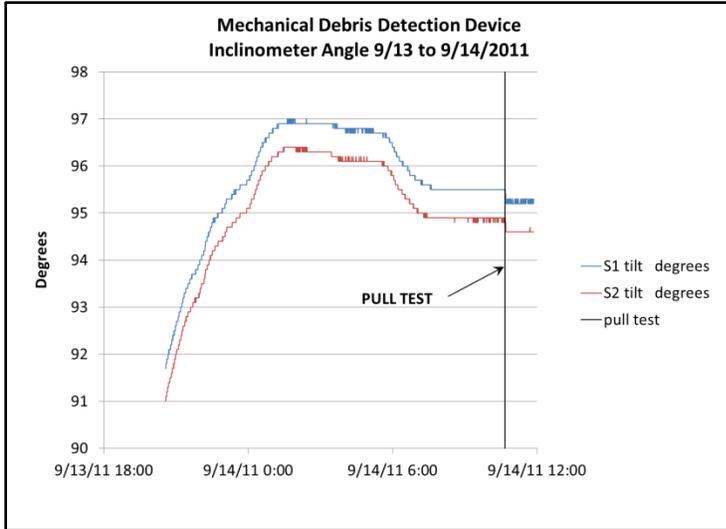
Figure 11 Inclinerometer 9/13 to 9/14/2011

Figure 11 displays the change in attitude of the MDDD after deployment. The offset between the reported angles of the two spines may be attributed to slight differences in mounting angle and this could be corrected in the future in adjusting the data logger program. The operation of the inclinometers was not checked after the system was assembled in Nenana prior to deployment and the angles reported are assumed to be within a few degrees. The close correlation of the data from both sensors suggests the reporting change in angle to be accurate to within a small fraction of

a degree. The change in angle is attributed to the settling of the anchor after deployment on 9/13/11. An increasing angle represents a greater settling of the upstream or fluke end of the anchor. During the pull test on 9/14/11 visual observations of the exposed spine tips indicated that the anchor shifted many centimeters. A shift in attitude of less than a degree is indicated by the tilt sensors at the time of the pull test.

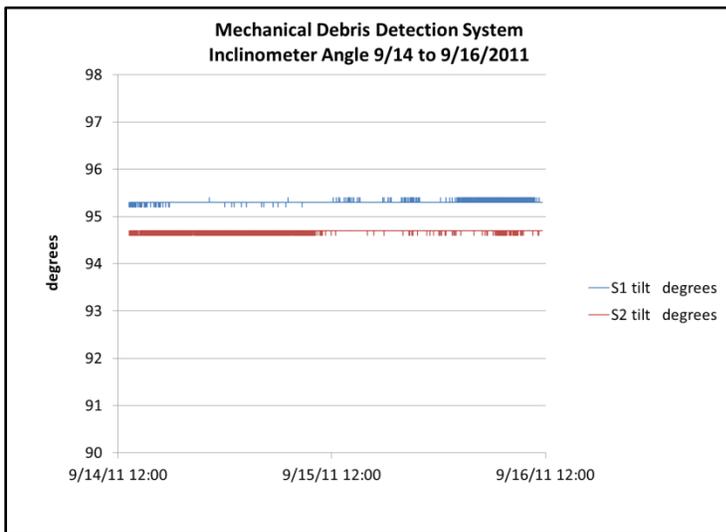
Figure 12 indicates that after the pull test the attitude of the anchor remained stable.

Figure 12 Inclinerometer 9/14 to 9/16/2011

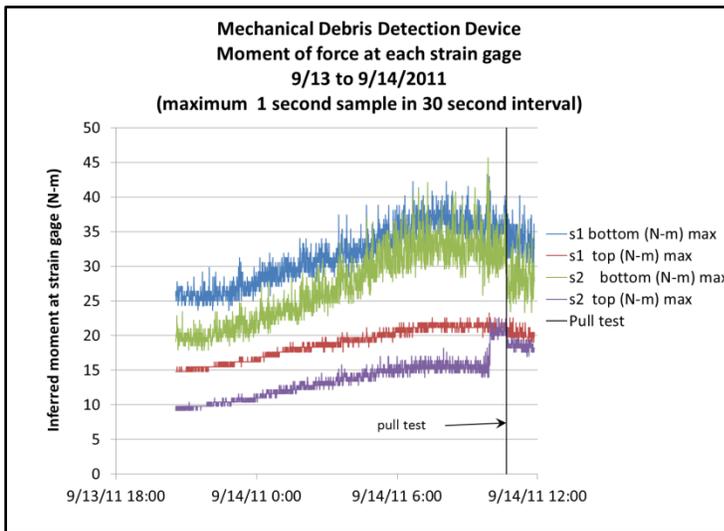
Figures 13 and 14 indicate the response of the strain gages to the forces on the spine between 9/13 and 9/14/2011. Figure 13 presents the maximum force recorded in each 30 second sampling interval of 30 one second samples and Figure 14 presents the average for the 30 samples in each interval. The forces on the spine changed a small amount at the time of the pull test at approximately 10:29. About ½ hour prior to the pull test, an event occurred that registered on the all of strain gages. The change indicated by the S2 top gage seemed to be anomalous because of the large change and that it did not go back to its original condition as did the others. An additional force that remained on the upper part of the spine should have been registered by both the top and bottom gages and this does not seem to be evident.

Figure 13 Strain gage maximum samples 9/13 to 9/14/2011

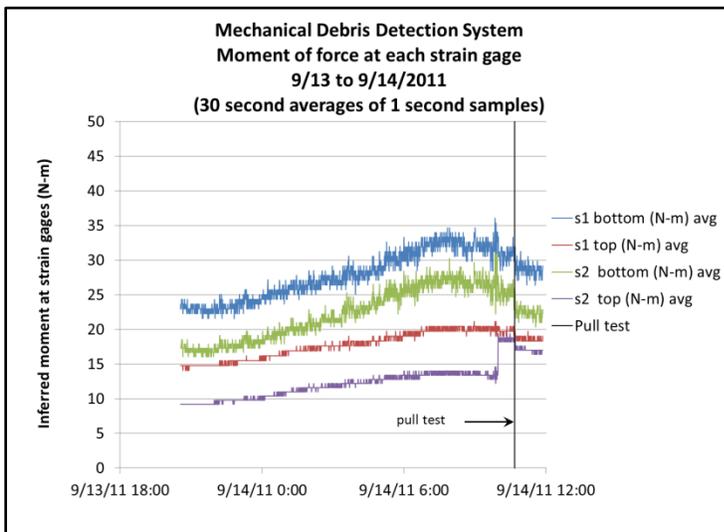
Figure 14 Strain gage sample averages 9/13 to 9/14/2011

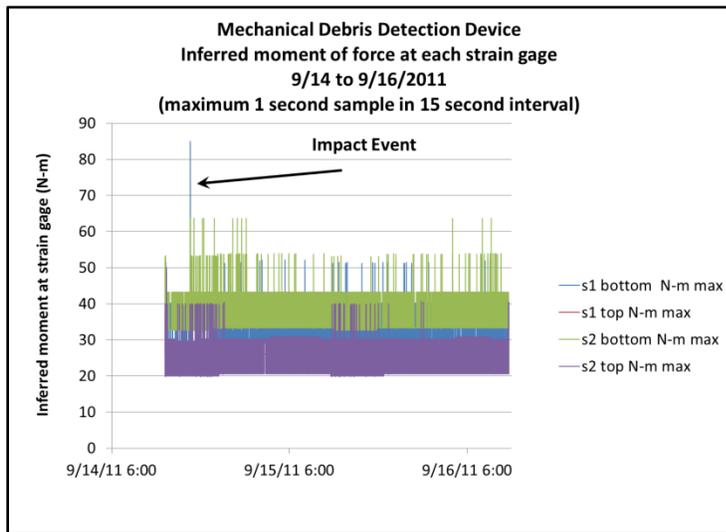
Figures 15 and 16 present the data from 9/14 to 9/16/2011. During this period the data logger was programmed to record at 15 second intervals and with minimum resolution. The signal resolution set in the program was relatively low and resulted in a resolution of approximately 10 N-m. Even so, the data for the two day period indicated the MDDD operated well. The values reported during this period were higher than in the previous period. A physical change in the surroundings occurred between Tuesday, 9/13 and Friday, 9/16. A tug and barge was moored less than 100 meters upstream from the deployed MDDD on Tuesday and by Friday afternoon it had moved to a downriver location. The time of this move was not noted and the evidence of this is in photographs of the Crowley dock taken on Tuesday and Friday. The system recorded what appears to be an impact event on the afternoon of 9/14/2011.

Figure 15 Strain gage maximum 9/14 to 9/16/2011

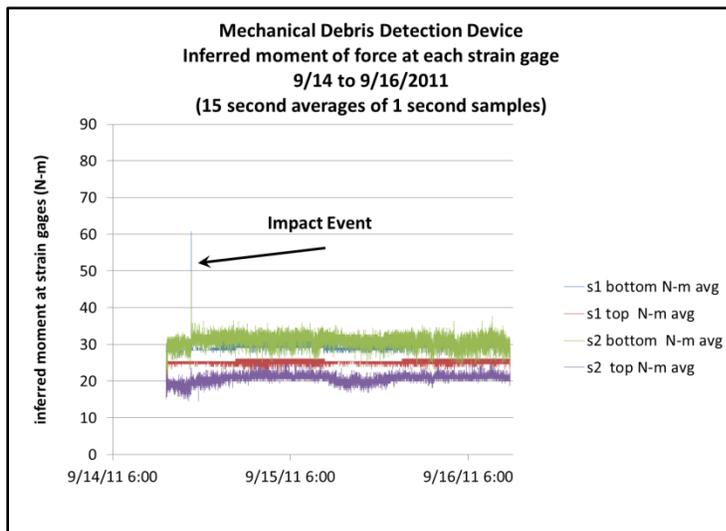
Figure 16 Strain gage sample averages 9/14 to 9/16/2011

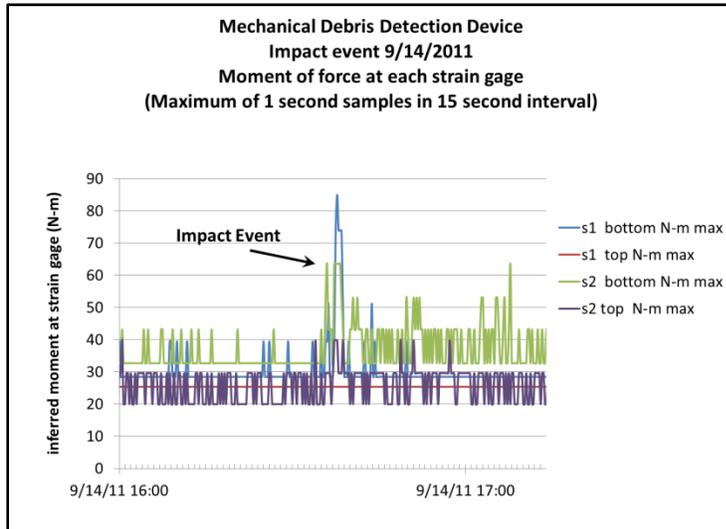
Figures 17 and 18 report the data for a one hour and fifteen minute period during which an apparent impact event occurred. The impact was noted on the three strain gages, S2 bottom and top and S1 bottom.

Figure 17 Strain gage maximum, impact event 9/14/2011

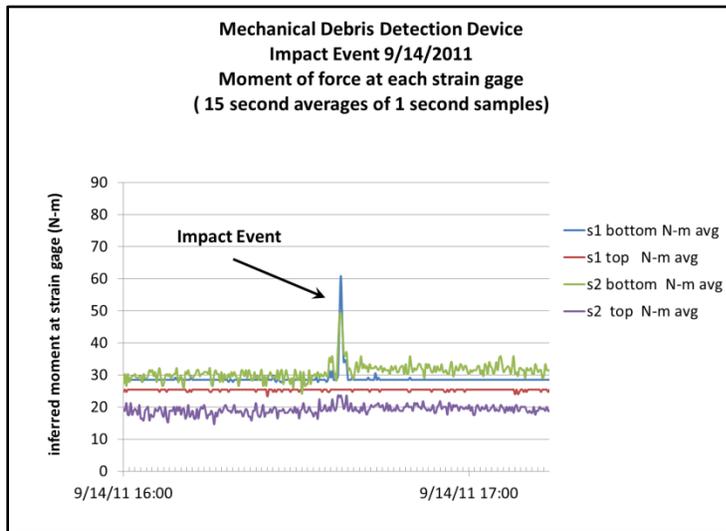
Figure 18 Strain gage sample averages, impact event 9/14/2011
