Kotzebue Electric Association
Solar Thermal Alternative Residential Heating Methods

Quarterly Report

3/31/2011

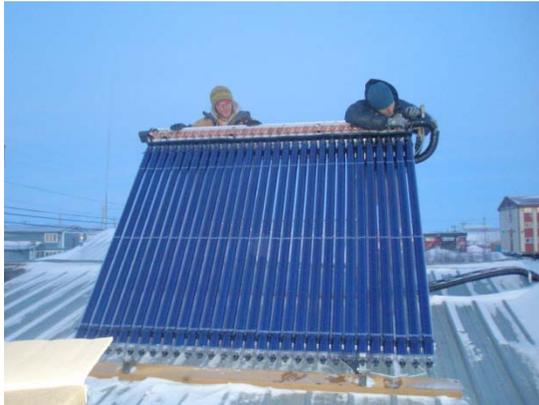
Viessmann 1: David Lindeen (SES) and Jesse Logan (KEA)

Vitosol 300-TSP3 (30) Evacuated Tubes.

Vitosol 300-TSP3 (30) Evacuated Tube (@ 68 degrees)

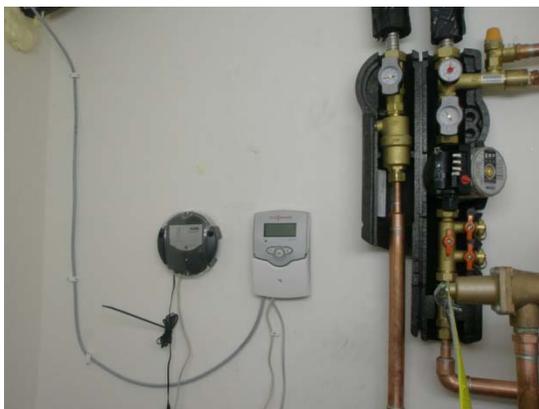
Viessmann 1: Utility Room

Preliminary wiring From Left to Right:
Resol Data logger DL2
SCU 124 (7416043) Control Unit
Solar Divicon DN-20 w/ Star 16U-15 Circ Pump

As with all the Viessmann systems the controls and data logger are separate units and communicate via a VBus connection. Data is stored in the DL2 and retrieved via SD card slot or connected to a computer via Ethernet LAN. SES was not familiar with the DL2 and could offer very little assistance in the set up, logging or data retrieval methods. Resol software is required to communicate with the DL2 directly or alternatively, to format retrieved data via SD card.

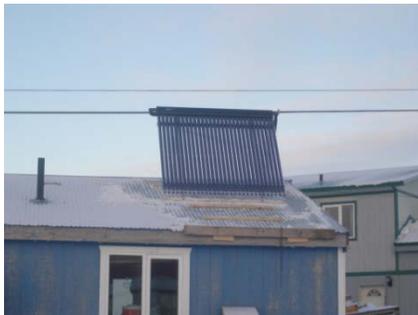
King Span solar evacuated tube (30) (@ 68degrees)

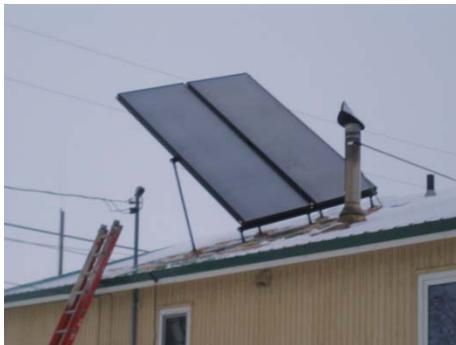
Gobi 410 flat plate (2). Mounting brackets rated to withstand 100mph winds.

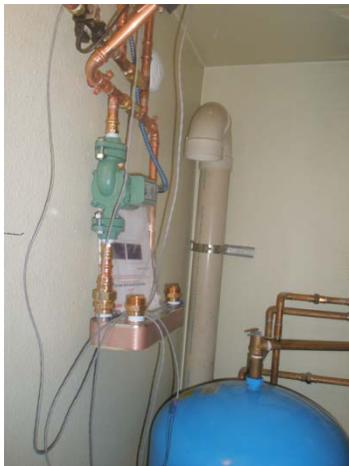
Auxiliary pump and flat plate heat exchanger for hydronic base board heating loop.
