Kotzebue Electric Association  
Solar Thermal Alternative Residential Heating Methods

Quarterly Report

12/29/2011

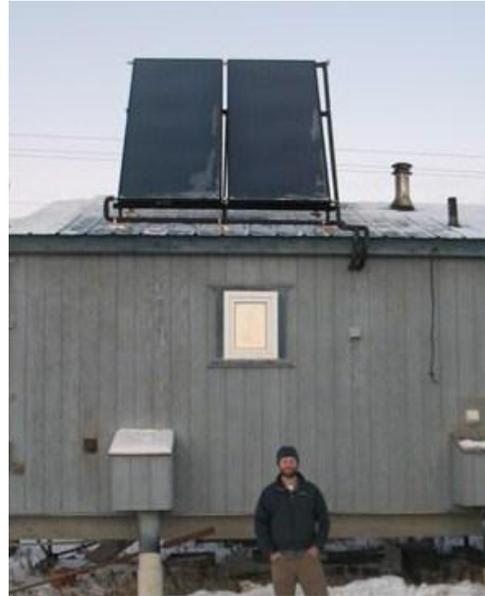
Heliodyne Flat Plate Solar Collector.  
Jesse Logan (KEA).

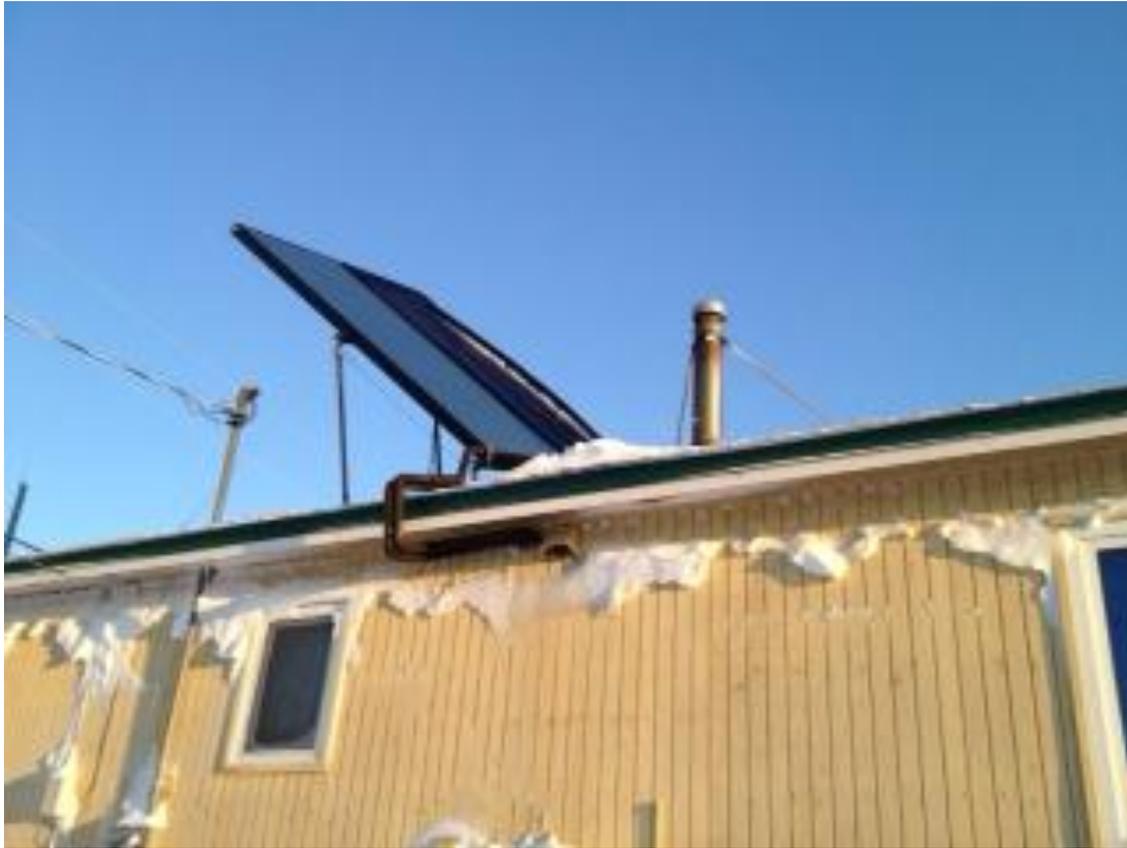
In November of 2011 a severe winter storm hit the west coast of Alaska causing damage from Nome to Kotzebue. Recorded winds were above 70 miles per hour in the Kotzebue region. While both the Viessmann and Heliodyne systems are rated for wind speeds in excess of 100 miles per hour severe damage occurred to two Heliodyne flat plate collectors- one collector on two different systems (see pictures below). A wind loading analysis was done by ABS and found no fault in the installation site, placement, or angle. The orientation of both of these collectors is within 5 degrees of due south and the strongest wind gusts came from the East by Northeast. It is possible that strong wind collided with the collector's eastern corner and produced a vacuum on the front of the collector panel causing the protective layer to shear off. These systems are currently not functional.

Picture 1: Wind damaged Heliodyne flat plate collector

Heliodyne has agreed to honor their manufacturer's warranty and will replace the two (2) flat plate collectors. KEA is in discussion with the installation company (Alaska Battery Systems, Fairbanks) to find the most economical way to ship and install the new collectors. Severe winter conditions in the Kotzebue region during January and February may delay the installation. It is not thought that the down-time of these systems (occurring in November through January or February) has caused a significant loss of production due to lack of solar radiation during these months above the Arctic Circle.

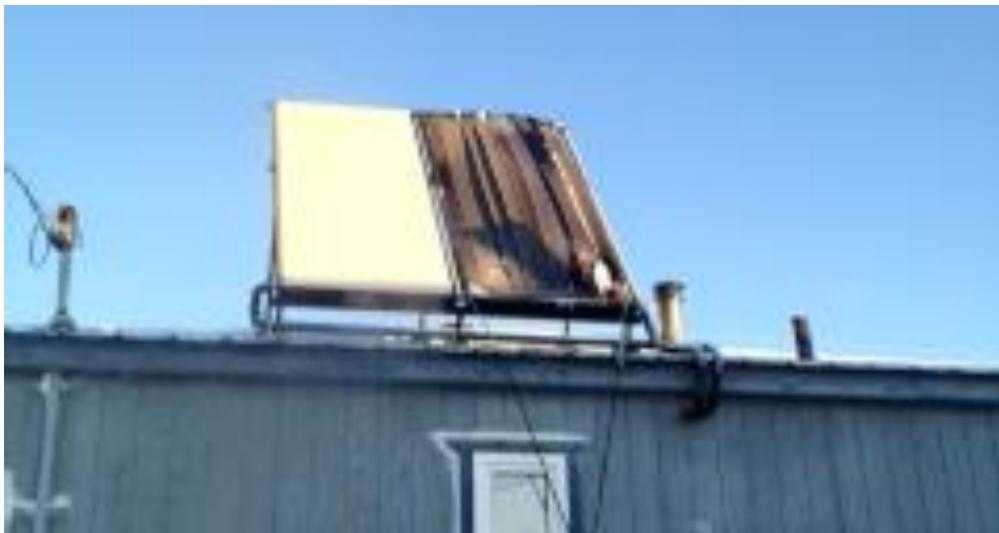
Picture 2: Wind damaged Heliodyne flat plate collector
